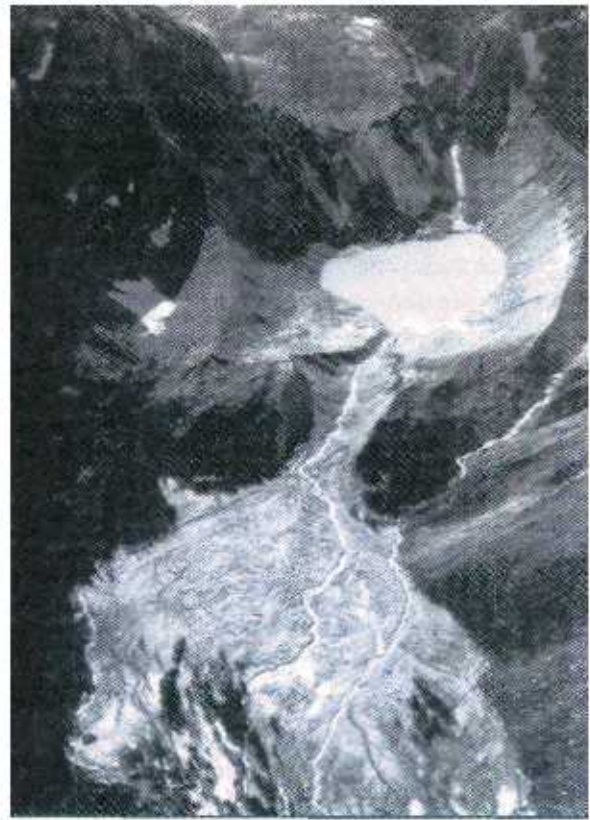
Photo 16. Typical outburst of a moraine-dammed glacier lake: A displacement wave generated by a huge ice fall overtopped the terminal moraine, surged down the steep outer face, and began eroding a narrow breach into the dam by retrogressive erosion. The lake emptied in several hours, resulting in a devastating debris flow (From Evans and Clague, 1994).

The State Committee on Emergencies (1997) refers to outbursts of moraine-dammed glacier lakes. However, the mode of failure of moraine-dammed lakes may be quite different from overtopping failure of landslide-dammed lakes. In most cases of overtopping of a moraine-dammed lake, the surge wave rushes down the steep outer face of the moraine and starts eroding the dam at its toe (photo 16). By retrogressive erosion, a narrow and steep breach is formed which, when reaching the lake itself, leads to emptying in only a few hours (Lliboutry et al., 1977; Evans and Clague, 1994; Hanisch et al., 1998). Because of the comparably flat outer face of the Usui dam, this mechanism of failure is extremely unlikely in the present case.
