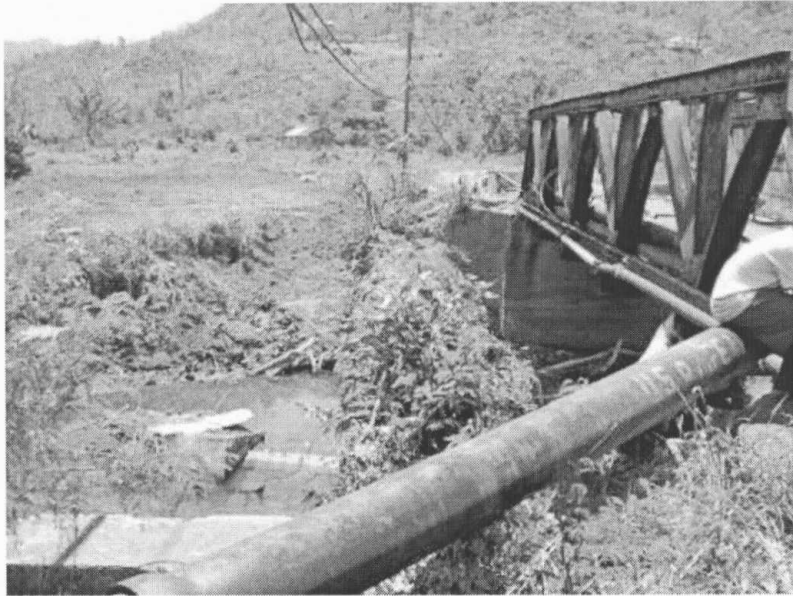
Photo 6 Damaged Water Supply Infrastructure at Beausejour

Damage was spread across the island, but was worse in the southern and eastern parishes.

Rehabilitation strategies include:

1. An initial temporary cleaning of all dams (already completed)
2. Proper cleaning of dams on a systematic basis. Three dams have already been properly cleaned, Concorde, Vendham and Radix. Annandale is to be cleaned by excavator by the end of September, 2004. It should be noted that restoration activities have been hampered by the relatively remote locations of many dams and consequent lack of access.
3. Temporary repairs to the trunk main on the Beausejour Bridge were made, however, these have to be redone and made permanent.
4. The distribution system at the Les Avocats site also needs to be repaired.

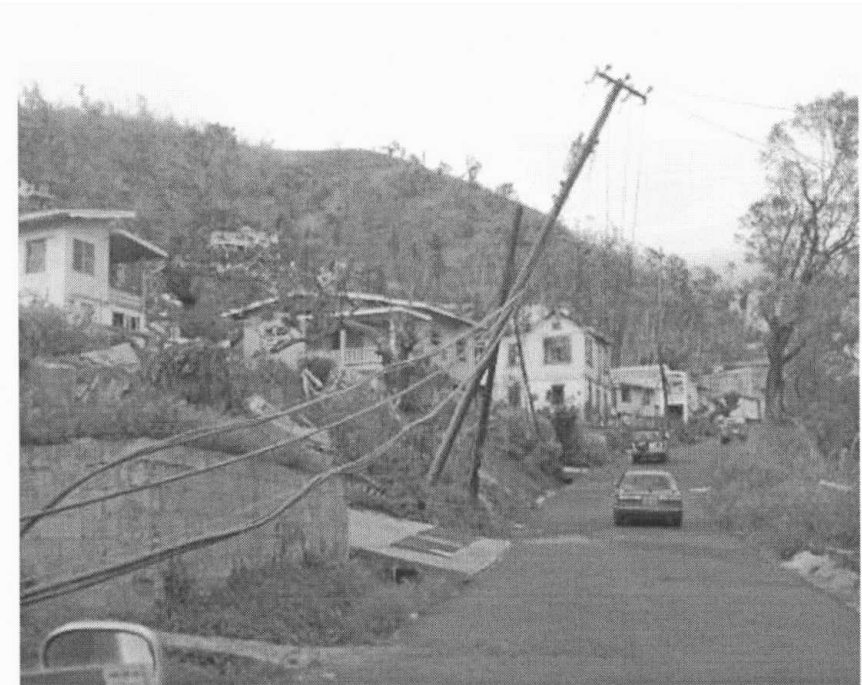
Photo 7 Downed Poles Carrying Communication Cables

- Both cellular and land line networks remain largely in operation
- The lines on the east coast were installed underground, whereas those on the west coast were largely above ground. As a result, significant damage was sustained to poles on the west coast.

- All cell sites were installed with generators.
- Significant damage was sustained to overhead fibres and to distribution lines, for which it is estimated that there was a 60% loss island-wide.
- Damage was also caused post-storm by people driving over lines and accidentally chopping cables as part of clean-up efforts.
- After the hurricane, it was discovered that the antennae (i.e. sectors) at several cell site locations had been blown off alignment by the wind. These all had to be realigned.

Restoration efforts have been ongoing since the hurricane, and Cable & Wireless have carried out restoration activities in concert with GRENLEC, with whom it shares the use of poles. At time of writing of this report, the following was the status of the restoration strategy.
